ENRICHED ALUMINIDE COATINGS FOR
DISPERSION STRENGTHENED NICKEL MATERIALS

M.A. Levinstein

GENERAL ELECTRIC COMPANY

NASA-Lewis Research Center
Contract NAS3-14314
J. Smialek, Project Manager

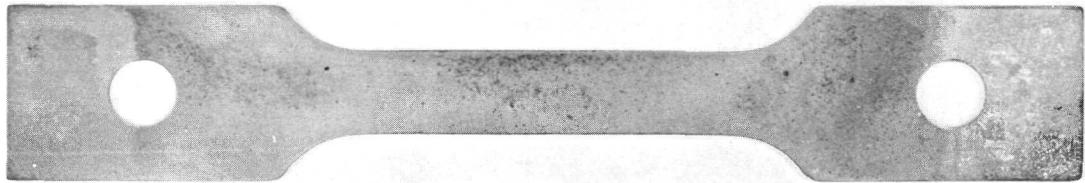
Figure 51. Group III TDNiCr Specimens, X40 Barrier, After 300 Hours of Oxidation Testing at 1422°K (2100°F)
